MINERALOGICAL ANALYSIS OF ROCK WEATHERING AND ITS INFLUENCE ON SLOPE FAILURE ALONG THE JAYAPURA CITY RING ROAD

Abstract

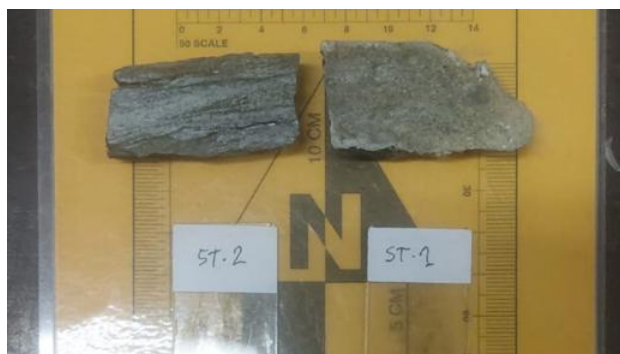
Figure 1. Rock samples

This study adopted a case-study design with an integrated field–laboratory approach to examine the relationship between rock weathering, mineralogical alteration, and slope failure along the Jayapura City Ring Road in eastern Indonesia. The sampling strategy was purposive rather than randomized. Two representative rock blocks, designated ST-01 and ST-02 (Figure 1), were selected directly from the failure zone of the shotcrete-reinforced slope based on three criteria: the visible weathering intensity, lithological variation, and proximity to the damaged slope surface. This sampling logic was appropriate because the purpose of the study was to characterize the failure mechanism of a specific slope segment rather than to estimate population-level parameters across multiple slopes.

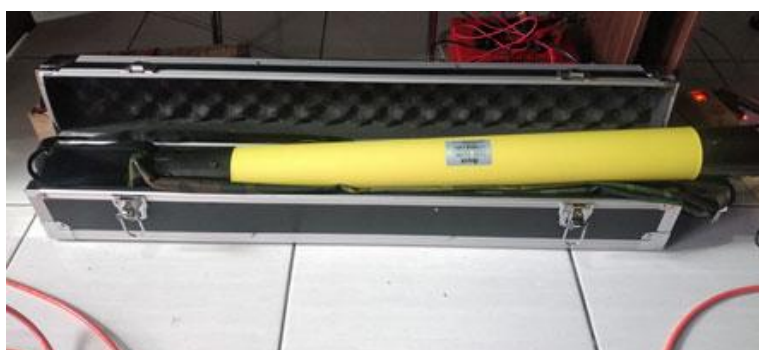
Figure 3. ADMT 3000-HT type resistivity instrument

Resistivity measurements were conducted using an ADMT 3000-HT (Figure 3) system with an effective investigation depth of up to ~300 m, depending on the signal penetration and the local subsurface conductivity. This method relies on naturally occurring electromagnetic (EM) fields and records orthogonal electric (E) and magnetic (H) components in the frequency domain at the Earth's surface. The subsurface resistivity is inferred from frequency-dependent variations in these field responses. The EM spectrum utilized spans approximately 0.0001–10,000 Hz, where high-frequency components (>1 Hz) are primarily associated with lightning activity, intermediate frequencies (<1 Hz) with ionospheric resonance, and low-frequency signals (<<1 Hz) with solar-induced variations (Grayver, 2024). As EM fields propagate into the ground, conductive heterogeneities generate secondary (eddy) currents that are detected and used to reconstruct resistivity profiles. The interpretation assumes plane wave propagation, with mutually perpendicular E and H fields and is governed by Maxwell's equations (Barajas-Olalde et al., 2023; Castillo-Reyes et al., 2025).

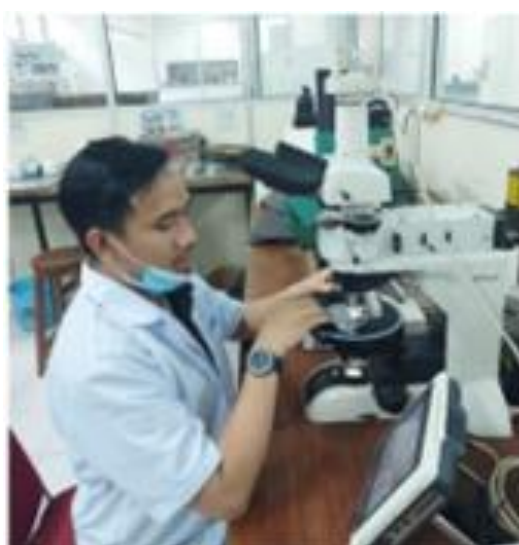
Figure 4. Process of petrographic analysis

Two representative samples, ST-01 and ST-02, were prepared as thin sections for petrographic analysis using a Nikon Eclipse LV600D polarizing microscope (Figure 4). Thin-section preparation followed standard laboratory procedures, including cutting, mounting, grinding, and polishing of the samples. Rock fragments were bonded to glass slides using Petropoxy 154 and ground to a thickness of approximately 30 μm using a Maruto ML-110NT system. Carborundum and fine alumina were used during the abrasive stages, followed by diamond paste polishing to produce optical transparency under transmitted light.
