Journal of Geology Mengkarang  
(2026) Vol. 01, No. 1, 33-47  
DOI: <https://doi.org/10.22437/jogm.v1i1.53586>

# Determination of Slope Stability Safety Factor based on the Slope Mass Rating (SMR) Method and Linearity Analysis of Discontinuity Conditions and Orientations using Linear Regression Machine Learning: a Case Study of the Breksi Cliff Area, Yogyakarta

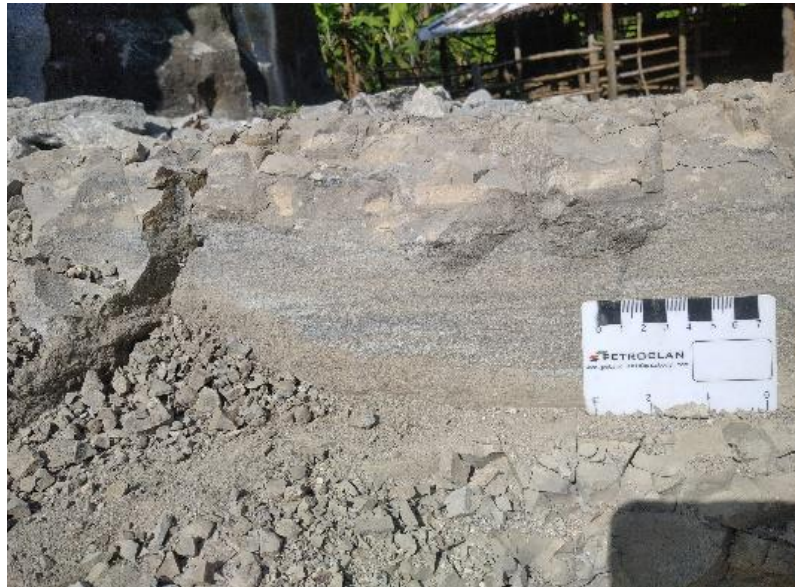
**Figure 5.** Tuff rock outcrop

Documentation of field conditions, including location, date, time, weather conditions, and rock descriptions based on physical (megascopic) characteristics.

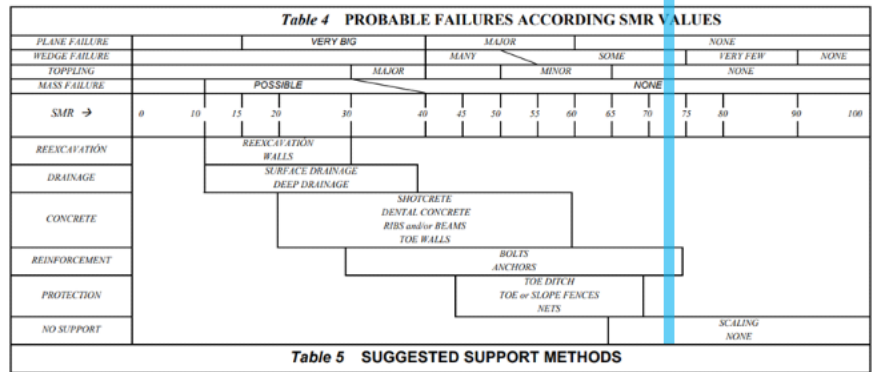
**Figure 11.** SMR classification (Romana et al., 2003, in Romana et al., 2015).

The calculated SMR value is 73 (Table 2), which falls within Class II and is categorized as Good rock mass quality, with a dominant toppling failure mode. The studied slope exhibits relatively stable conditions, with the potential for failure involving some rock blocks. Occasional support may be required, and recommended support measures include the installation of rock bolts (anchor bolts), although in some cases no additional support may be necessary.

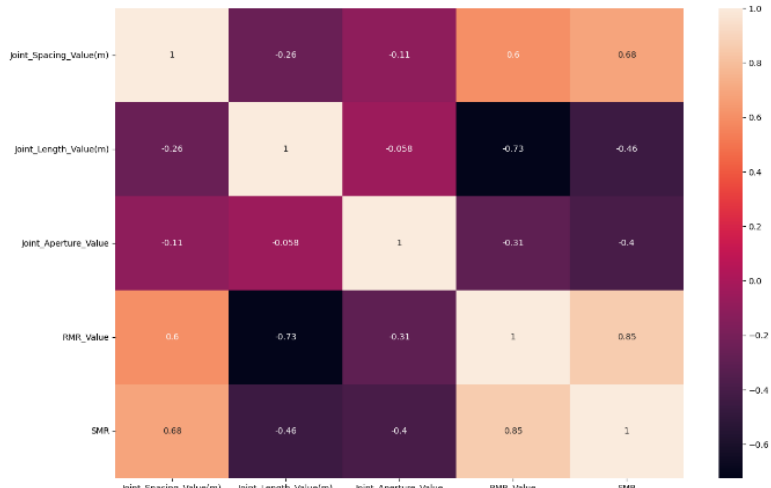
Figure 13. Heatmap condition of discontinuity with RMR-SMR value

Heatmap visualization of the relationships between discontinuity condition variables and RMR–SMR values is presented in Figure 15. Discontinuity spacing shows a positive correlation with RMR values of 60% and SMR values of 68%. This correlation pattern is consistent with the linear regression model results shown in Figures 17(a) and 17(b), indicating a positive linear relationship. Increasing discontinuity spacing is therefore associated with improved slope stability.

Discontinuity persistence (length) exhibits a negative correlation with RMR values of 73% and SMR values of 46%. This relationship corresponds with the linear regression results shown in Figures 15(c) and 15(d), which indicate a negative linear trend. As discontinuity persistence increases, slope stability tends to decrease.

Discontinuity aperture also shows a negative correlation with RMR values of 31% and SMR values of 40%. This relationship is consistent with the linear regression results presented in Figures 15(e) and 15(f), indicating a negative linear relationship. Larger discontinuity apertures are therefore associated with reduced slope stability.
